Manhole Inspection Summary

Manhole # S21MM_015MH

Insp Date: **7/3/07 9:45 AM**

Location Address: **2237 FULTON AVE**

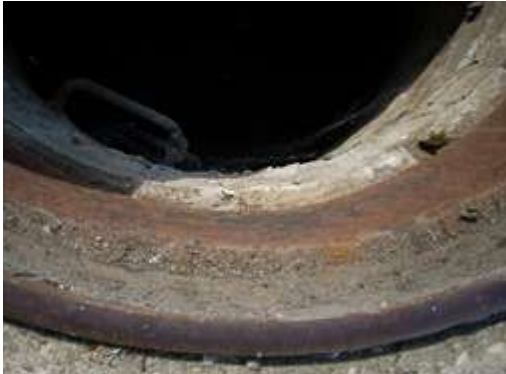
Defect 1

Frame Offset: **1** (in.) Condition: ☒ Sound ☐ Cracked ☐ Leaks

FRAME OFFSET

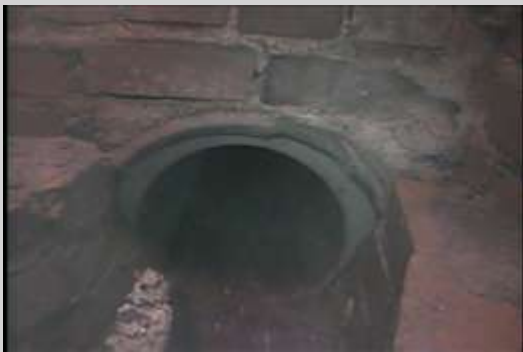
12 O'Clock Outflow

10 in. Circular Gravity Sewer
Pipe Out @ 12 O'Clock

Pipe Height: **10.8** (in.) Rod and Bar (Angled)
Pipe Material: **Clay** ☐ Pipe Lined
Invert Depth: **7.61** (ft.) Flow Characteristics: **Slow**
Deposits: ☒ None ☐ Mud ☐ Sludge ☐ Debris ☐ Grease
Silt Depth: (in.) Deposits Extent:
Infiltration: **None** Pipe Seal Cond: **Sound**

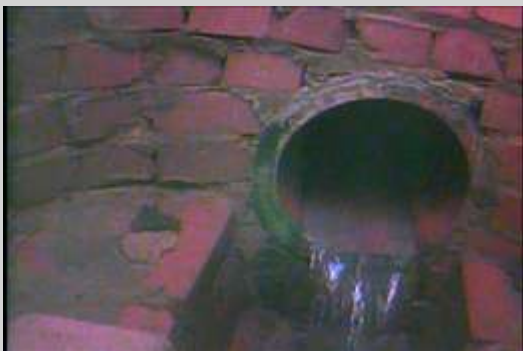
9 O'Clock Inflow

10 in. Circular Gravity Sewer
Pipe In @ 9 O'Clock

Pipe Height: **10.8** (in.) Rod and Bar (Angled)
Pipe Material: **Clay** ☐ Pipe Lined
Invert Depth: **6.95** (ft.) Flow Characteristics: **Slow**
Deposits: ☒ None ☐ Mud ☐ Sludge ☐ Debris ☐ Grease
Silt Depth: (in.) Deposits Extent:
Infiltration: **None** Pipe Seal Cond: **Sound**
